CASE STUDY

SPR™

STUTT GART, GERMANY

DN2320/1900 (91.3/74.8 in), 260 m (853 ft)

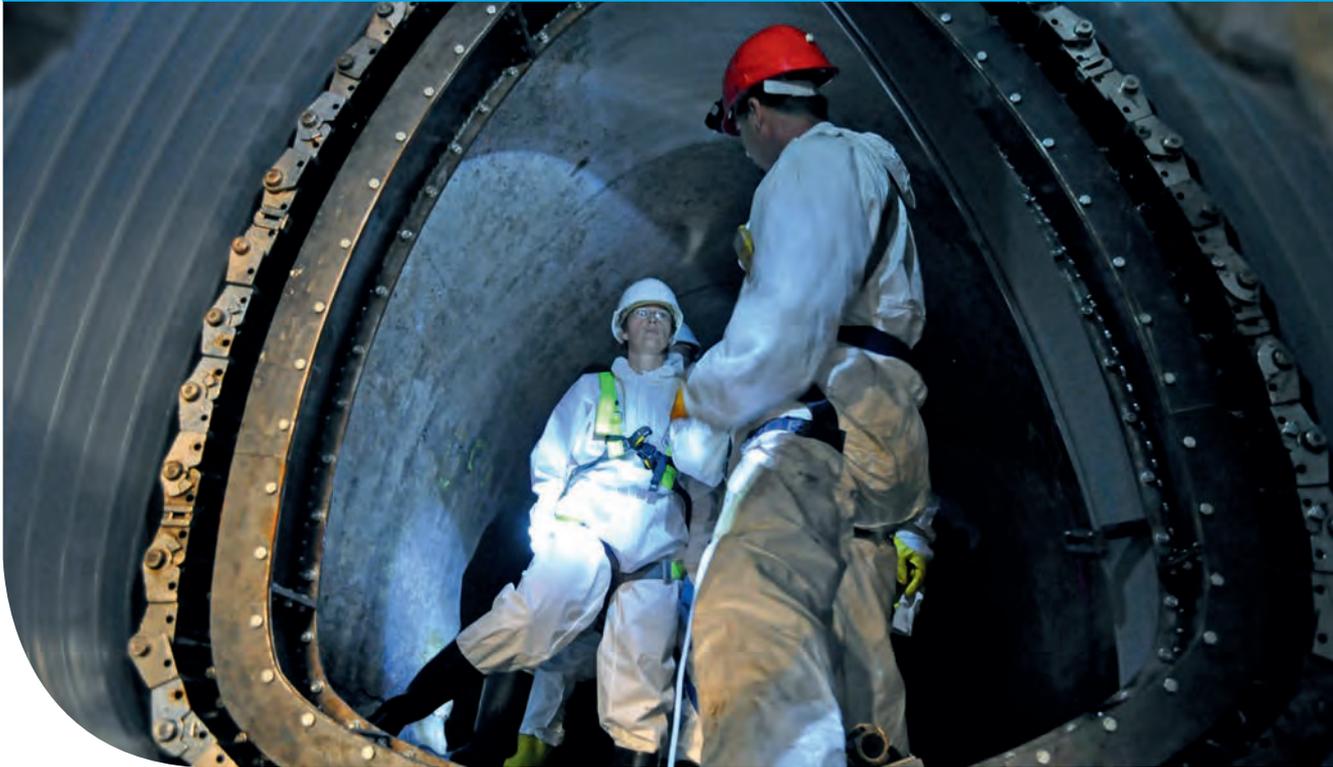
Rehabilitation with an interceptor beneath the Leuzetunnel. It was the largest diameter ever rehabilitated with the SPR™ Spiral-Wound in Germany.

The SPR™ Spiral-Wound pipe lining method by SEKISUI SPR Europe – by which a plastic profile strip with key-and-slot joint is unwound into the old sewer – was tailor-made for this rehabilitation project. A standard manhole suffices for the introduction of process engineering equipment and material.

The steel-reinforced plastic endless profile and patented winding frame, specially constructed for the size and geometry of the respective sewer enables not only circular profiles, but also any other special profiles to be wound.

After the installation the created annular gap between the host pipe and the wound PVC liner was filled with a special high-strength grout.

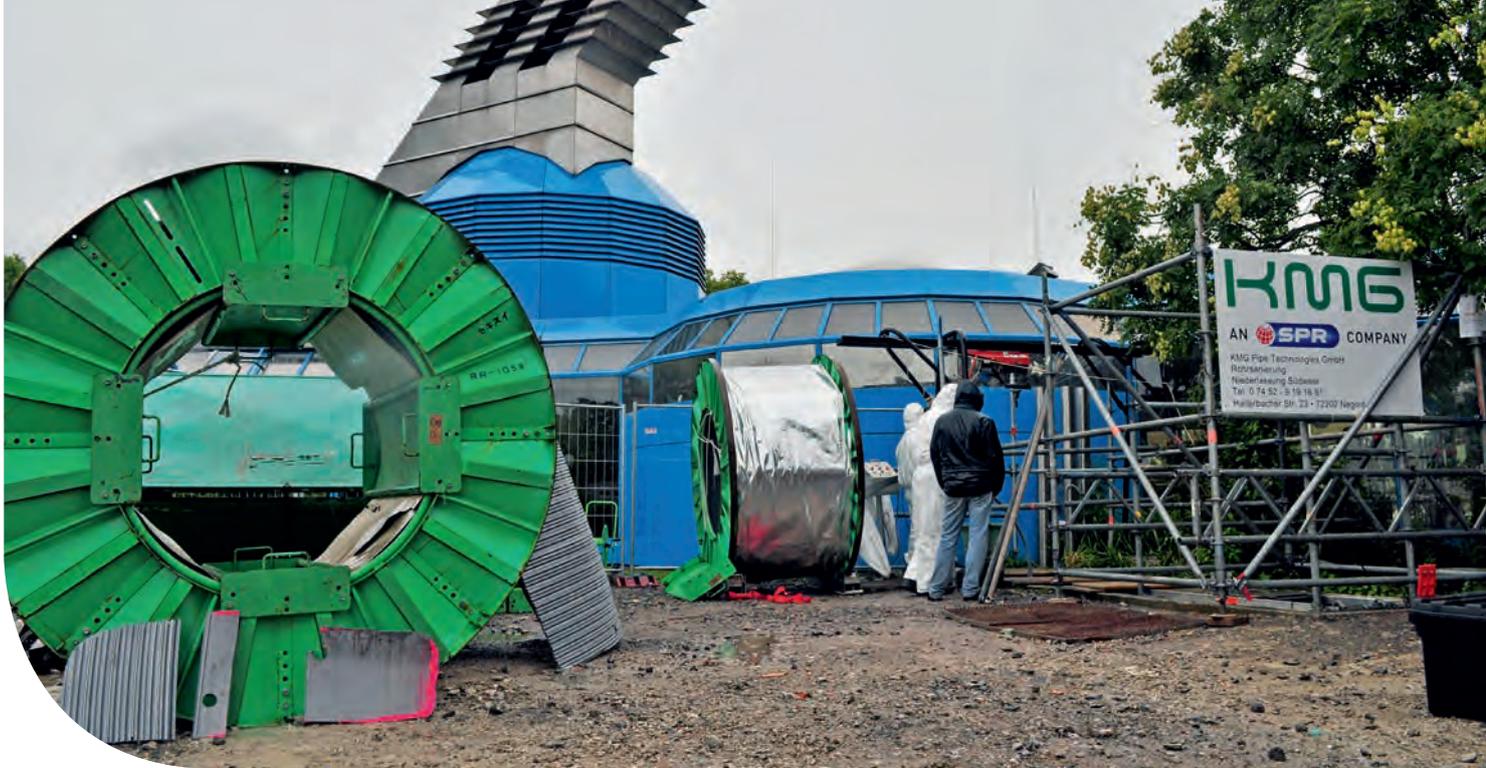
location within the lift zone of the mineral springs, the carbon dioxide content is increased. This is extremely damaging to mineral structures and exerted particular strain on the largest width of the main sewer. The dome profile with the dimensions 2320/1900 mm (91.3/74.8 in) was constructed in 1961 and suffered heavily under the acid attack lasting half a century. A further complication in this project was that all three sections to be rehabilitated had different profiles.

Probably the most restrictive factor was the extremely poor accessibility of all sections, whose crown is up to 10 m (32.8 ft) below the surface. In two sections the sewer could only be reached via a 12-metre (39 ft) deep access shaft immediately adjacent to the entrance of the Leuzebad.
