SPR™ ST CASE STUDY

'NO DIG' STRUCTURAL LINING FOR SAN DIEGO CULVERTS

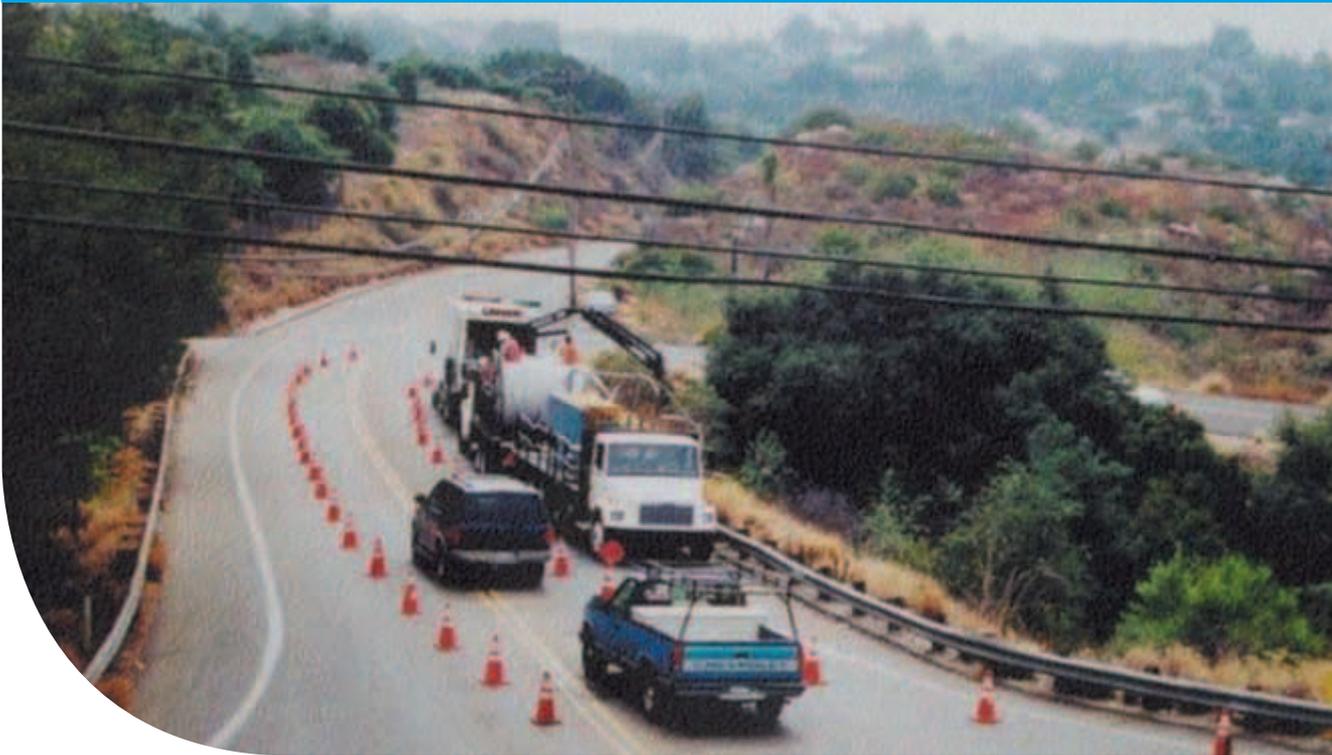
SPR™ ST lining meant no disruption above or below ground

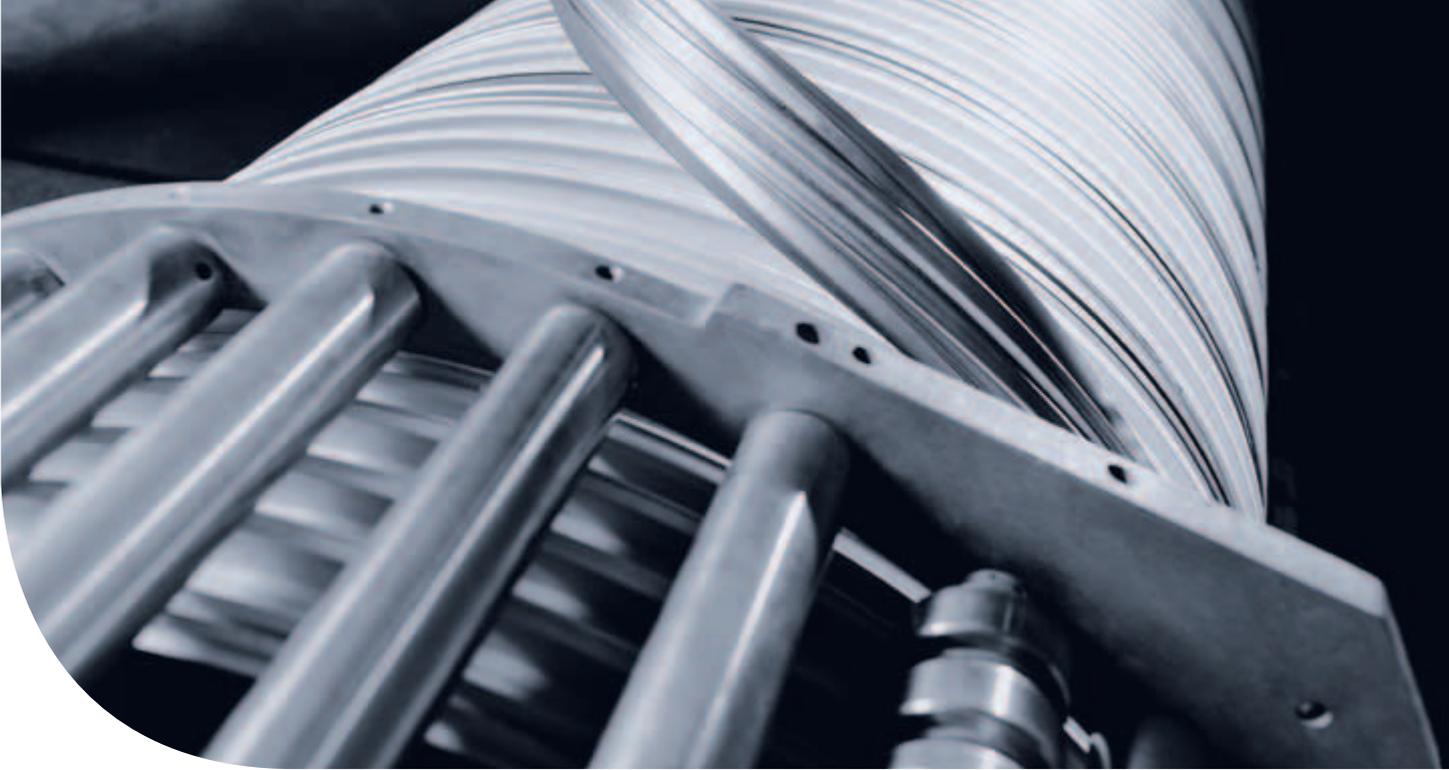
Two sections of 910mm (36 in) diameter corrugated metal storm culvert running under Honey Springs Road in San Diego County were on the verge of collapse.

The invert of the culvert had rusted out, and the supporting bedding soil had been eroded away.

SPR™ ST 126-20RS profile with steel reinforcement was selected for this project. Cementitious grout was used to fill the annulus between the existing culvert and the fixed diameter liner.

To alleviate concerns that grout may migrate into the stream running through the pipe, four tons of stone were used to rebuild the invert prior to lining. The invert was then sealed with quickset mortar.
