CASE STUDY

SPR™

EAUBONNE, FRANCE
DN1150/2600 (45/102 in), 110 m (360,9 ft)

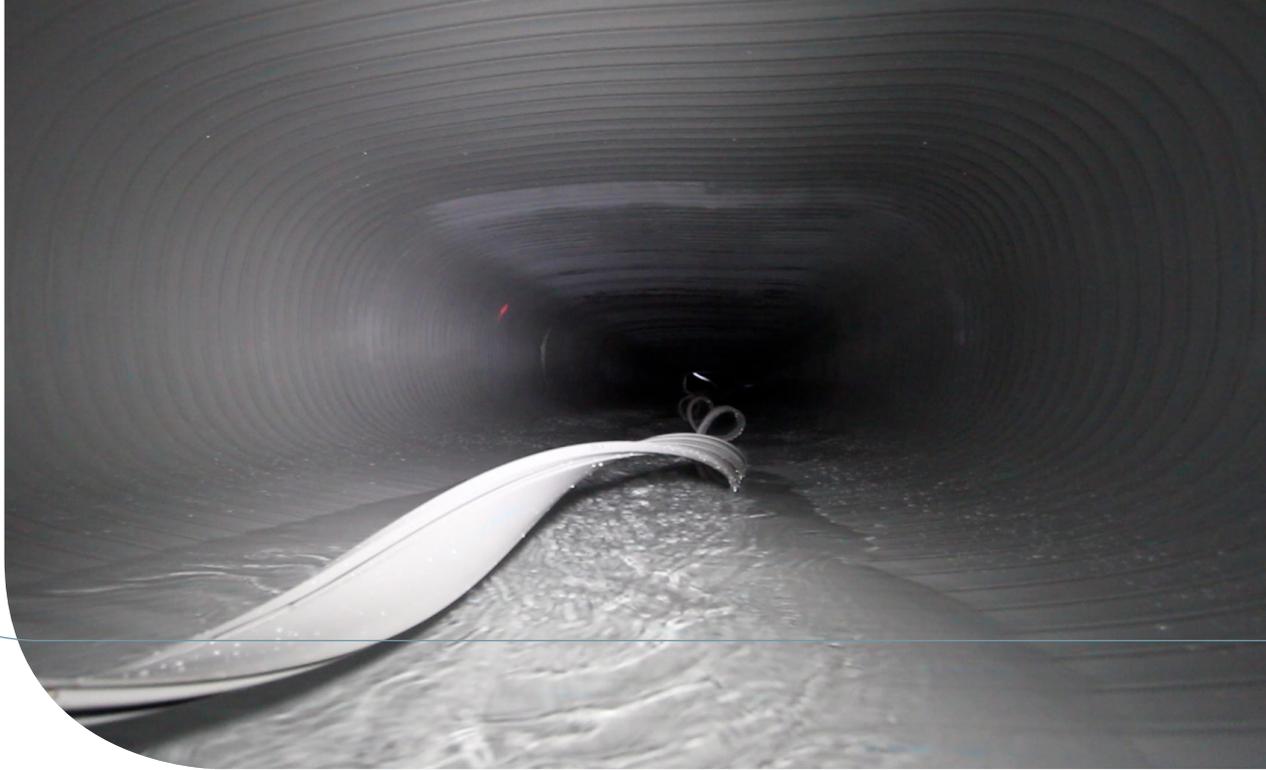
A watertight pipe with high hydraulic performance is the result of the Spiral-Wound pipe rehabilitation method.

The SPR™ Spiral-Wound pipe rehabilitation technology rehabilitated the 110 m (360.9 ft) decayed sewer section by winding an endless PVC profile strip to a new pipe in the old pipe. A special spiral-winding machine crawled along

the full length of the structure, combining with every rotation the SPR™ profile strip to a watertight pipe by a key-and-slot joint. The frame of the directly in the sewer installed machine was adjusted to the particular box shape and dimension. Liners of any length can thus be created: as soon as one of the 13 above-ground profile drums was empty, a new one was welded onto it. After the winding process, the annular space between the SPR™ liner and the old pipe was backfilled with a high-strength grout that ensures the static characteristics of the Spiral-Wound pipe. The 10° bend as well as several lateral connections were no problem and could be relined in one step.
